# Bone-Hydroxyapatite Interface in Retrieved Hydroxyapatite-Coated Titanium Implants: A Clinical and Histologic Report

Two hydroxyapatite-coated implants were retrieved after 12 months of loading because of a fracture of the abutments. The specimens were treated to obtain thin ground sections, and a microprobe chemical analysis was done under a scanning electron microscope equipped with an energy-dispersive x-ray analysis and cathodoluminescence system. Under light microscopy, close contact between the bone and the hydroxyapatite coating was seen, with no gaps at the interface. In some areas of the coating a reduction of the coating thickness could be observed, along with the presence of some detached hydroxyapatite particles embedded in newly formed bone. The chemical analysis of the cathodoluminescent areas at the interface showed a reduced calcium:phosphorus ratio in this region.

(INT J ORAL MAXILLOFAC IMPLANTS 1999;14:233-238)

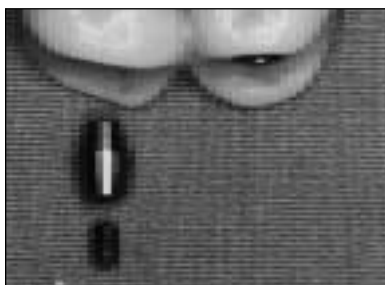
**Fig 2a** (Left, top) Fracture of the abutments.

Two HA-coated titanium implants (Sustain, Lifecore, Chaska, MN) were placed in the posterior mandible. After 12 months of loading (Fig 1), both abutments fractured (Fig 2), and it was necessary to remove both implants. The implants were retrieved with a trephine, and after fixation, the specimens were sectioned in half longitudinally by the Precise 1 Automated System (Assing, Rome, Italy).<sup>11</sup> One half of each specimen was dehydrated in an ascending series of alcohol rinses and then infiltrated in Technovit 7200 VLC resin (Kulzer, Wehrheim, Germany) and polymerized. The blocks were then sectioned to 200  $\mu\text{m}$  and then ground to approximately 20 to 30  $\mu\text{m}$ . The slides were stained using basic fuchsin and toluidine blue and examined under a Laborlux light microscope (Leitz, Wetzlar, Germany). The other half of each specimen was processed for scanning electron microscopic (SEM) analysis. After the specimens were dehydrated with a critical point dryer and sputtered with a carbon film, a microprobe chemical analysis was performed using a Zeiss DSM 960 scanning electron microscope (Zeiss, Oberkochen, Germany) equipped with an energy dispersive x-ray analysis and cathodoluminescence system.

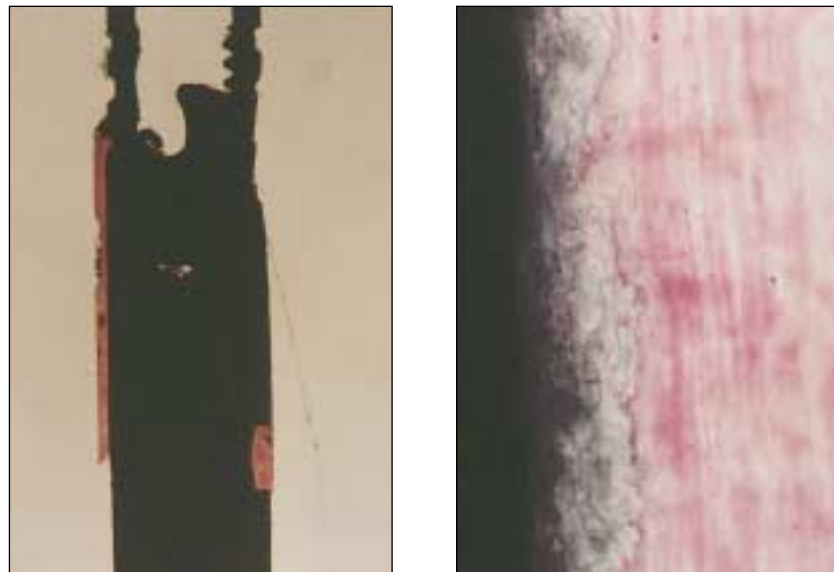
could be seen on the surface of the implant (Fig 3). The fact that bone was present on only one side of the implant was the result of trephine bur action during retrieval of the implant. The incomplete adaptation of the abutment to the inner portion of the implant could be observed, and biologic tissues were interposed between the 2 structures. Intimate contact between HA and bone was seen around almost all of the implant perimeter, without the presence of a connective tissue capsule or of an inflammatory reaction (Fig 4). Macrophages and inflammatory cells were absent. Some small (20- to 100- $\mu\text{m}$ ) HA fragments had detached from the surface of the coating and they were completely surrounded by newly formed bone (Fig 5a). In only a

**Fig 5a** In some portions of the interface a resorption of the HA coating can be seen. Some detached HA particles are found embedded in newly formed bone (*arrows*). Biologic material is present inside the coating (basic fuchsin and toluidine blue; original magnification  $\times 400$ ).

HA particles were always surrounded by newly formed bone and no untoward effects were observed.
