Development and Treatment of Retrograde Peri-implantitis Involving a Site with a History of Failed Endodontic and Apicoectomy Procedures: A Series of Reports

Key words: apicoectomy, debridement, dental implants, endodontics, retrograde peri-implantitis, tetracycline

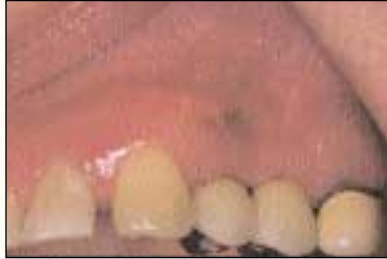
Fig 1a Patient 1. Note draining fistulous tract on the buccal attached tissue opposite the implant on area of the maxillary left first premolar.

Eighteen months after the implants were loaded, the patient was referred to the clinic by her general dentist regarding a swelling in her left anterior maxilla. The general dentist had started the patient on a course of antibiotics. Clinical examination revealed a draining fistula in the mucosa between the maxillary left canine and implant site (Fig 1a). The canine tested vital. A periapical radiograph revealed a radiolucency at the apex of the implant at the first premolar site (Fig 1b). Surgical exploration and debridement were recommended.

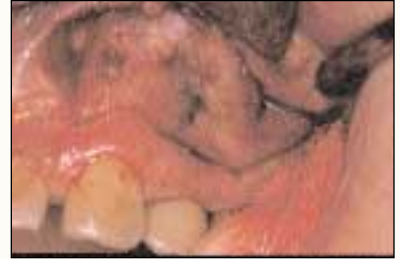
Fig 1c Flap elevation reveals what appears to be soft tissue in the area of the implant apex.

Surgical Procedure. A flap was elevated facial to the canine and the implants replacing the premolars (Fig 1c). Granulation tissue and purulent material were removed from a bony defect approximating the apex of the implant in the first premolar site (Fig 1d). Necrotic tissue was removed from the open vent at the apex of the implant. The bony defect, the implant apex, and the mid-lingual aspect of the canine were thoroughly debrided of granulation tissue (Fig 1e). The implant apex and the bony defect were then coated with tetracycline paste (250 mg powder mixed with sterile water to form a paste) (Fig 1f). The tetracycline paste was left in place for about a minute, and the area was then rinsed and flushed. This procedure was repeated twice. After thorough irrigation (Fig 1g), the flap was repositioned and sutured with a 4-0 plain gut suture (Fig 1h). Eight months after the surgical treatment, the implant was in function and symptom-free. A periapical radiograph taken at this time shows partial resolution of the peri-implant radiolucency (Fig 1i).

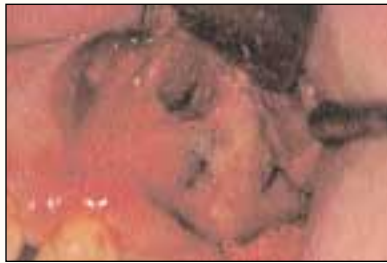
Fig 1d A bony defect is apparent after curettage and removal of infected tissue.

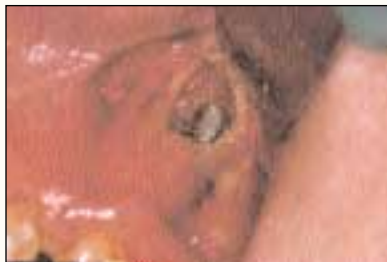
Fig 1g The area has been thoroughly rinsed and irrigated.

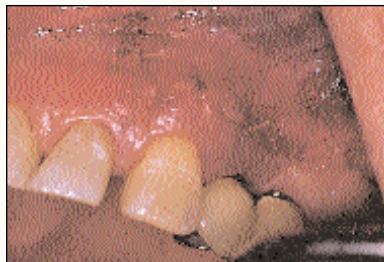
Fig 1h Flap closure.

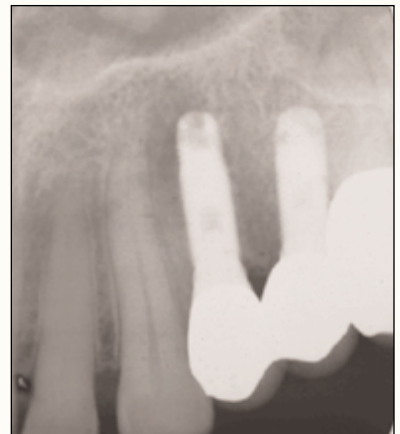
Fig 1i Eight months after treatment, partial resolution of the radiolucency can be noted.

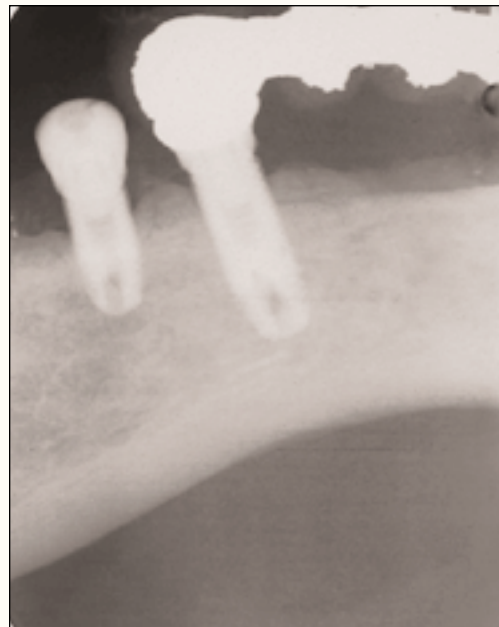
Fig 3b A radiograph taken 8 years after surgical treatment shows complete resolution of the peri-implant radiolucency.

Surgical Procedure. A flap was elevated buccal to the right lateral incisor, extending to the first molar area. A vertical releasing incision was made on the distofacial line angle of the right central incisor. The implant in the area of the canine appeared to be stable. A high-speed round bur was used to create an opening in the intact buccal plate of bone opposite the apex of the implant. Purulent material drained from a large bony defect approximating the apex of the implant. After adequate exposure, hand instruments were used to remove granulation tissue and infected material from the apical area and vent of the implant. The area was thoroughly irrigated. Tetracycline paste was introduced into the defect and applied to the exposed portion of the implant. The area was again thoroughly irrigated and the flap was repositioned and sutured with 4-0 Vicryl sutures. Since the procedure, the implant has been stable, loaded, and in function for 8 years without any further symptoms (Fig 3b).
