Corrosion at the Marginal Gap of Implant-Supported Suprastructures and Implant Failure

Purpose: Late failure, which occurs after successful osseointegration, is usually attributed to prosthodontic determinants. Corrosion of metallic suprastructures and incorrectly handled materials are often primary causes of late implant failure. In this study, 6 implants whose failure was related to suprastructure metal corrosion and adjacent bone were investigated. **Materials and Methods:** Six implants as well as their suprastructures were analyzed for surface corrosion using light and scanning microscopy. Metal alloys and soldering compounds were analyzed using energy-dispersive x-ray analysis. Bone adhering to the implants was removed and analyzed for metal content using atom absorption spectroscopy. **Results:** Extensive corrosion lesions and areas of oxidation were detected on all 6 of the implants and inner crown surfaces. Bone tissue collected from 5 of the implants showed higher contents of metal ions in comparison to physiologic baseline values detected in healthy bone. **Discussion:** In spite of the high gold content of the suprastructure, corrosion occurred. Bonding oxides necessa

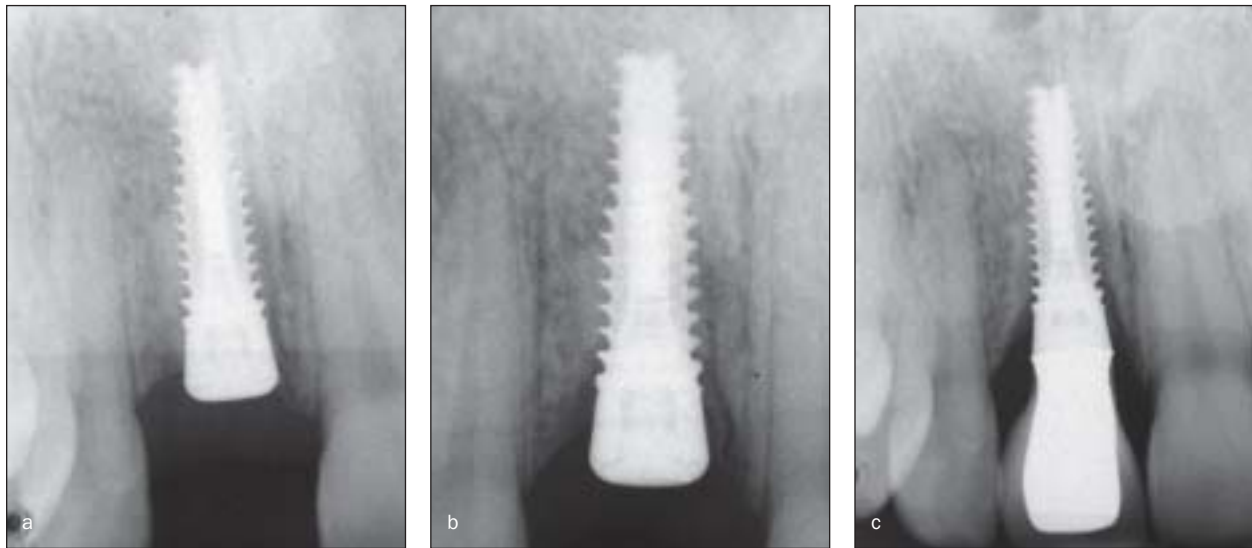
Fig 1 Radiographs showing the course leading to osseodisintegration of the implant in patient 6: (a) immediately after placement; (b) at reentry, immediately before abutment connection, and (c) after failure, immediately before removal.

bone adhering to the failed implants after removal, and the suprastructures they had supported were obtained, with the informed consent of the patients, so that they could be studied to determine the possible causes of implant failure (Figs 1a to 1c). The implants were placed at different sites by different oral surgeons, and the suprastructures were seated by different prosthodontists. The implants were identical in design; all had been acquired from the same manufacturer (HaTi Dental, Bettlach, Switzerland). The diameter and length of each implant varied depending on the available bone and suprastructure requirements. The suprastructures were produced by the same dental technician and were made of porcelain fused to gold. Creation 98 porcelain (Willi Geller, Baar, Switzerland) and V-Super-gold (Metalor, Neuchâtel, Switzerland) were used for all suprastructures. The declared contents of the high-grade gold alloy were 86% gold, 7% platinum, 4% palladium, and 1% silver. The remaining 2% comprised undetectably small amounts of cobalt, indium, and tin.

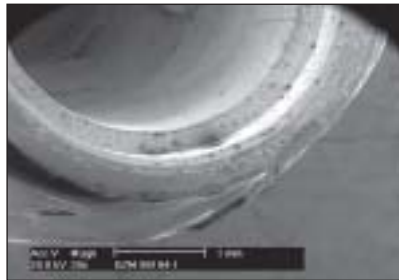
Fig 3 Scanning electron micrographs of the corroded crowns and implants.

Fig 3a (Left) The porous layer of the inner surface of a crown (original magnification $\times 20$).

All suprastructure crowns were made of a high-grade gold alloy that contained cobalt and indium as well as oxide layer-forming elements necessary for the process of fusing porcelain to gold. The surfaces of all of the crowns and implants showed extensive corrosion lesions and areas of oxidation (Figs 2 and 3). These corrosion lesions (crevice corrosion) were found exclusively at the crevice surfaces of the inside of the crowns. The bone tissue collected from 5 of the implants showed the incorporation of metal ions from gold, copper, cobalt, indium, palladium, and silver. Not enough bone could be collected from the sixth implant for an AAS analysis (Table 2). The bone samples collected showed different degrees of metal ion incorporation (Table 3).

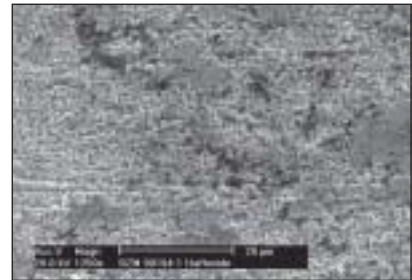
Fig 3b (Right) A corrosion-altered alloy surface in the region of the implant shoulder (original magnification $\times 1,250$).

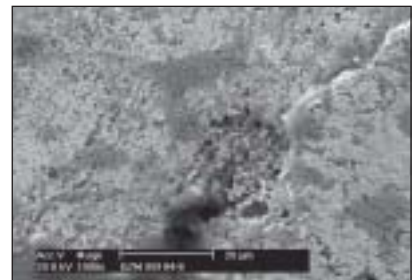
Fig 3d (Right) Severe corrosion lesions, surrounded by bonding oxide residue (original magnification $\times 1,000$).
