Human Histologic and Histomorphometric Analyses of Hydroxyapatite-Coated Implants After 10 Years of Function: A Case Report

Paolo Trisi, DDS, PhD¹/Daulton J. Keith, DDS, FICD²/Sabina Rocco, DDS³

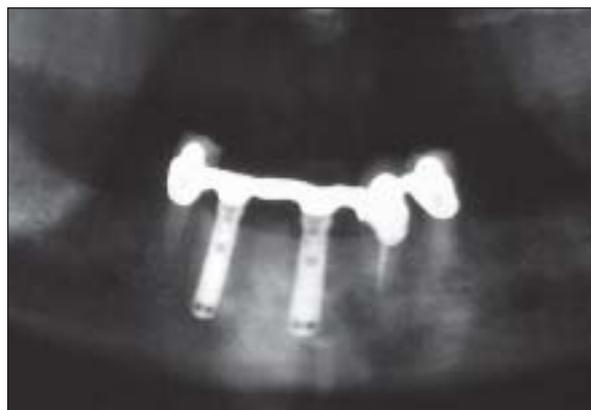
Fig 1 Panoramic radiograph taken after periodontal and surgical treatment.

In 1989, a 63-year-old white woman presented with a complaint of discomfort with her mandibular removable partial denture and dissatisfaction with the esthetics of her maxillary complete denture. She reported a history of right hip joint replacement in 1986, which necessitated antibiotic premedication for all dental procedures, and presented a long history of periodontal disease. In the mandibular arch, the left canine, left first premolar, and right first premolar were still present (Fig 1), and the patient was wearing her second removable partial denture.

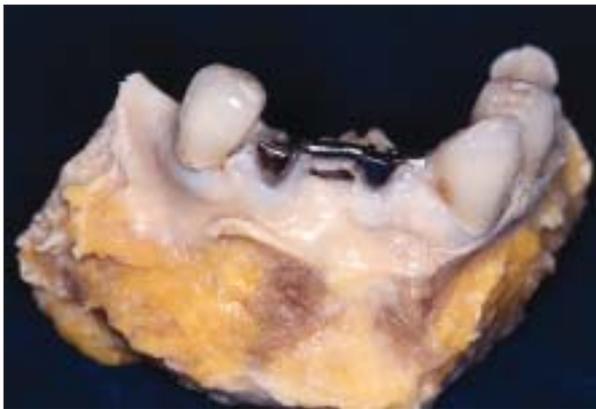
Fig 2 Postmortem block section of the anterior mandible. The section included the implants, natural teeth, and fixed prosthesis.

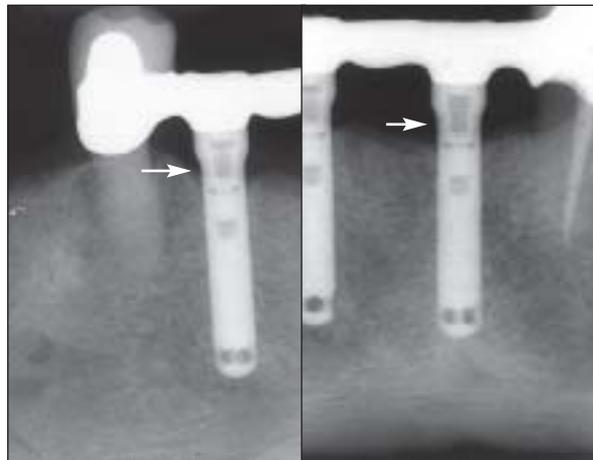
Fig 3 (Left) The right implant, which replaced the mandibular right canine. The periapical radiograph shows no signs of radiolucency. The implant-abutment interface (arrow) lies below the crestal bone level. (Right) The left implant, which replaced the mandibular left lateral incisor. There is no evident difference between the bone level at the 2 sides of the implant. The implant-abutment interface (arrow) is localized at the crestal bone level.

inflammation were visible either in the peri-implant or marginal periodontal tissues, and a wide adherent gingiva was visible around the necks of the implants. The follow-up period lasted 10 years. The last panoramic radiograph was taken in 1998. No bone loss was visible around the implants, and the bone level appeared to be well preserved at the natural teeth. The patient developed a disease that progressed rapidly; she died in July 2000 from septicemia resulting from gangrene of her right leg. Before her death she consented to donate her mandible for postmortem examination. The dissection included most of the mandibular body (Fig 2). Postmortem periapical radiographs showed no signs of radiolucency, infrabony pockets, or bone loss around the implants, and bone levels were maintained around the teeth (Fig 3).

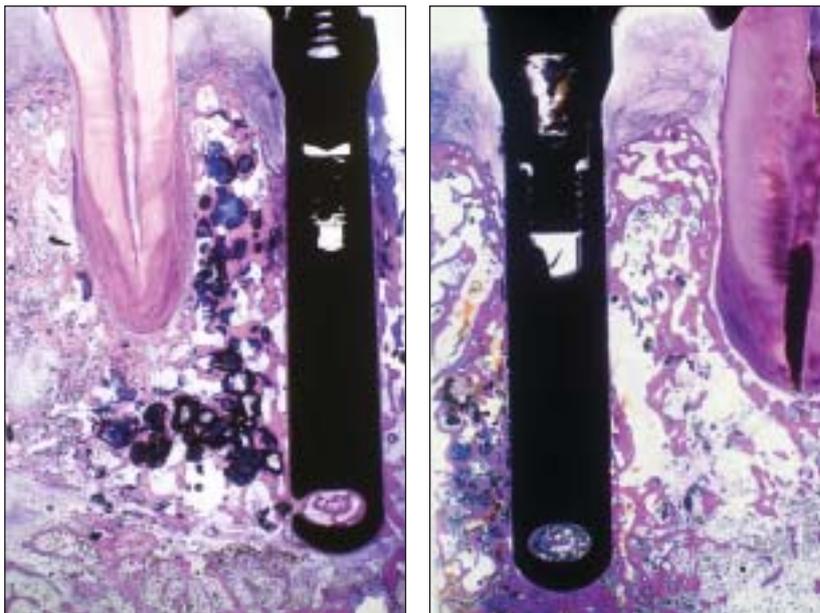
Figs 4a and 4b (Left) Histologic view of the right implant. The crestal bone level is above the implant-abutment interface and higher adjacent to the right first premolar than on the contralateral side. Note a vertical angular bone defect at the distal side. (Right) Histologic view of the left implant. Note the implant-abutment location. Bone density appears to be low around the implant body and neck and higher in the periapical region. Bone is clearly visible inside the apical vent (toluidine blue-basic fuchsin; $\times 2.5$).

At low magnification, the implants appeared to be well integrated (Fig 4). In the supracrestal tissues, it was possible to note limited epithelial growth along the implant surface (Fig 5). In the connective tissue, fibers were oriented parallel to the implant surface, and no signs of inflammatory infiltrate were observed. The supracrestal tissue will be described in detail and discussed in another study.

A vertical angular bone defect was visible on the distal surface of the implant replacing the mandibular right canine (Fig 4a). It was possible to observe how different the level of the implant-abutment interface was with respect to the bone crest level: At the implant replacing the left lateral incisor the interface was almost at the crestal level (Fig 4b), while at the implant replacing the canine it was below the bone crest (Fig 4a). At the coronal portion of the

Around the canine implant (Fig 4a), bone was uniformly distributed, with trabecules functionally oriented along the implant surface. In the endosseous portion of the lateral incisor implant (Fig 4b), bone appeared denser in the apical portion, and trabecules appeared to be thinner on the middle and coronal portions of the implant.

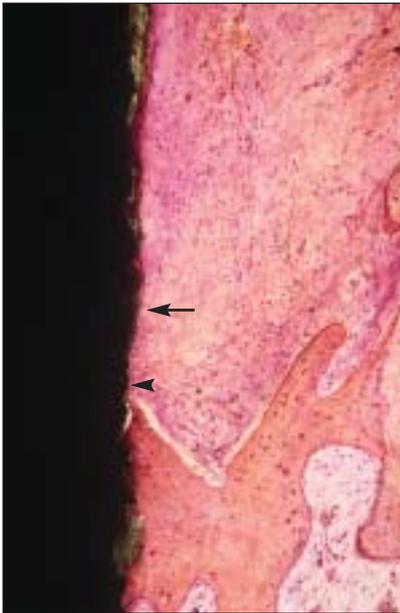
Fig 5 Marginal soft tissues around the left implant. The epithelium (*arrow*) ends below the implant-abutment interface. Note the BIC (*arrowhead*) where the HA coating disappeared (toluidine blue-basic fuchsin; $\times 5$).

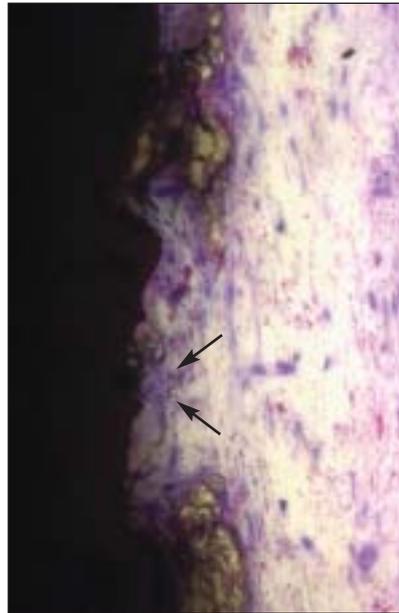
Fig 6 Soft tissue in contact with the coronal portion of the left implant. HA has disappeared in a few areas. A macrophage is visible over the titanium surface, but no inflammatory infiltrate is present (*arrows*) (toluidine blue-basic fuchsin; $\times 40$).

implants surrounded by marginal soft tissues, HA coating was absent in some limited areas and the connective tissue was in direct apposition with the underlying titanium surface (Fig 6).

areas, HA was absent or reduced in thickness (Fig 9), and the metal implant surface was in direct contact with bone or in contact with bone medullar spaces (Fig 8). In several locations, a sharp passage was evident between areas without coating and areas where the coating was of normal thickness (Figs 6 and 9).

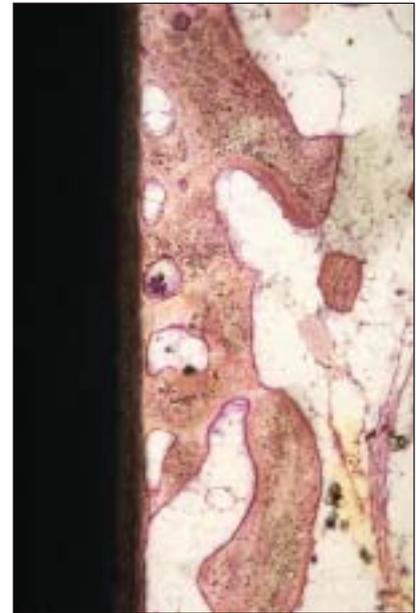
Fig 7 Coating is maintained on most of the surface of the left implant. A continuous layer of bone is visible in direct contact with the HA. Bone trabeculae are perpendicularly oriented toward the surface (toluidine blue-basic fuchsin; $\times 10$).

At higher magnification, a thin continuous layer of lamellar bone was evident on most of the implant surface in tight apposition with the HA coating (Fig 7), which was maintained on most of the surface. BIC was evident also in the apical vent of both the implants examined (Fig 8). Bone appeared especially dense in the apical vent of the canine implant. A neurovascular bundle was visible in close apposition to the apical portion of this implant (Fig 8). In limited

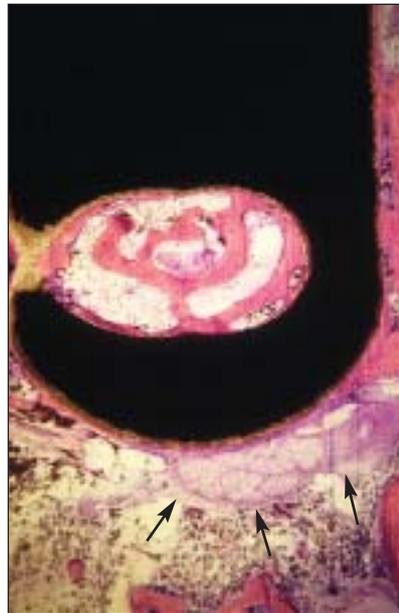
Fig 8 (Left) The apical region of the implant replacing the lateral incisor. BIC is almost 100% inside the apical vent. Note the neurovascular bundle (*arrow*) close to the apical portion of the implant (toluidine blue-basic fuchsin; $\times 2.5$).

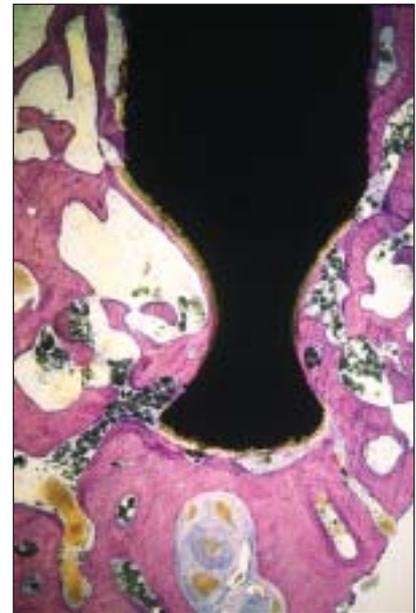
Fig 9 (Right) In limited regions of the implant surface, HA coating is absent, and the bone is in direct contact with the titanium surface (toluidine blue-basic fuchsin; $\times 2.5$).
