In Vitro Evaluation of the Implant-Abutment Bacterial Seal: The Locking Taper System

Serge Dibart, DMD¹/Martha Warbington, MS²/Ming Fan Su, DMD MS³/Ziedonis Skobe, PhD⁴

Key words: bacterial seal, implant-abutment connection

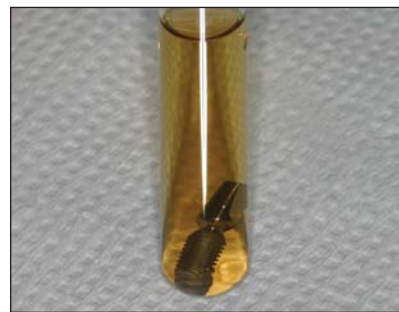
Fig 4a (Left) The left glass tube shows disassembled implant abutment with inoculant in nutrient broth (positive control). Notice cloudiness of broth as a sign of bacterial growth. The middle and right glass tube show assembled implant abutments with inoculant in clear nutrient broth (no bacterial growth).

Fig 4b (Right) An assembled sterile implant-abutment unit in nutrient broth. The broth is clear and shows no evidence of bacterial contamination (negative control).

abutment units containing $0.1 \mu\text{L}$ of bacterial gel) showed a clear broth at the end of the 3 days of incubation. The 3 positive controls (unassembled implants and abutments with $0.1 \mu\text{L}$ of bacterial gel) showed cloudy broths, which confirmed the viability of the microorganisms throughout the experiment (Fig 4a). The last 3 samples, "noninfected" implant-abutment units (ie, the negative controls), were used to check for microbial cross-contamination during the experiment. These samples also had clear broths (Fig 4b). From each of the 15 glass culture tubes containing the test and control samples, $20 \mu\text{L}$ of broth were sampled at 24, 48, and 72 hours. These broth samples were individually plated on tryptic soy broth yeast (TSBY) plates and incubated in the anaerobic chamber at 37°C for 5 days. The 9 test samples and the 3 negative controls showed no evidence of bacterial presence at 72 hours as could be observed on the agar culture plates (Fig 5). The broth from the 3 positive controls exhibited heavy bacterial presence when plated (Fig 5).

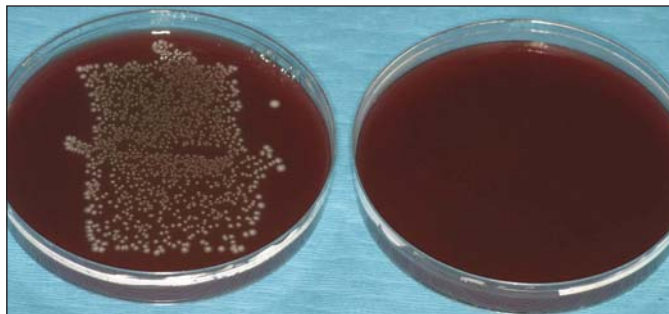
Fig 5 Culture plates after plating of 20 μ L of broth from test and control glass tubes (72 hours). The left plate shows bacterial colonies (positive control), while the right plate shows no bacterial growth (test group).
