Load Fatigue Performance of a Single-Tooth Implant Abutment System: Effect of Diameter

Christopher E. Quek, BDS, FRACDS, MDS, MRD RCSEd¹/Keson B. Tan, BDS, MSD²/Jack I. Nicholls, PhD³

Purpose: This study investigated the load fatigue performance of narrow-, regular-, and wide-diameter CeraOne (Nobel Biocare) single-tooth implants and abutments. **Materials and Methods:** Five samples of each implant-abutment combination in 3 different widths were tested at 3 applied screw torque levels (recommended torque, recommended torque +20%, and recommended torque -20%). A rotational load fatigue machine was used to apply a 21-N load, at an angle of 45 degrees to the long axis of the specimens. This loading produced an effective bending moment of 35 Ncm at the abutment-implant interface. An upper cyclic limit was set at 5×10^6 load cycles for all specimens. **Results:** Two-way analysis of variance revealed a significant difference between narrow-diameter and wide-diameter implant test groups but no significant difference between the 3 torque levels for each implant diameter. In the narrow-diameter group, 6 of the 15 specimens failed (5 abutment screw failures and 1 implant failure). In the

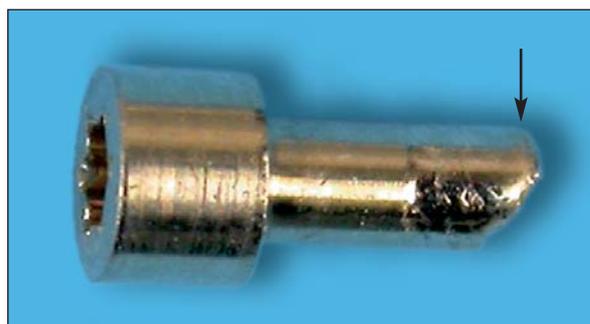
Fig 4 Failed abutment screw (sample R-/5) at the first thread (arrow).

Table 4 presents the data for the regular diameter (3.75 mm) abutment-implant combinations with the 3 different applied torque levels. Of the 15 specimens, 3 failed (2 implant fractures and 1 abutment screw fracture). The abutment screw failed in the first thread, at 1,207,260 load cycles (25.6 Ncm torque

level). This is shown in Fig 4. The 2 implant fractures occurred at 4,623,283 cycles (32 Ncm torque level) and 4,349,565 cycles (38.4 Ncm torque level). Both implants fractured at the start of the self-tapping thread notch (Figs 5a to 5c).

level of recommended +20%. For the regular-diameter implant, a single abutment screw fracture occurred at the recommended -20% torque level; this fracture also occurred at the first thread.

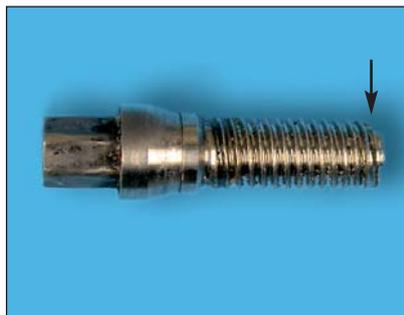
Fig 5a Fractured implant (sample R/0/1). The fracture occurred at the level of the start of the self-tapping notch (arrow).

It seems surprising that implant failures occurred in this study rather than failures at the first thread of the abutment screw. Yet 3 implants failed at the highest torque levels (at the recommended torque level for 1 RP failure and at +20% recommended for the remaining NP and RP failures). These failures occurred at an expected location, namely, at the plane of the start of the self-tapping notch on the external surface (Figs 5a and 5b). In essence, the implant in the PL-2 resin was a cantilever beam. As a result of the externally applied moment of 35 Ncm, the PL-2 resin applied a resisting stress along the length of the implant. The implant acted as a cantilever beam under these conditions, and this resisting PL-2 applied stress increases down the length of the implant. But at the self-tapping notch on the implant, there would be an increase in stress because of the abrupt change in geometry. This combination would lead to fatigue failure at this location. However, the threads on the external surface would also act as stress risers, and failure could also occur at one of these. So the starting point of the fracture at this location could have been either the top of the notch or 1 of the threads. The fact that implant failure occurred at the 2 higher torque levels suggests that the higher preload in the abutment-implant screw joint forced failure to the lower section of the implant. In addition, since the wide-platform implant did not exhibit implant failure, one can assume that the wider diameter reduced the stress in the implant to a safer level.
