Salivary Gland Injury Subsequent to Implant Surgery

Oded Nahlieli, DMD¹/Eitan Bar Droma, DMD²/Eli Eliav DMD, PhD³/Ami Zaguri, DMD⁴/
Rachel Shacham, DMD⁴/Tal Bar, DMD²

Key words: implants, ranula, salivary gland injury, sialoendoscopy

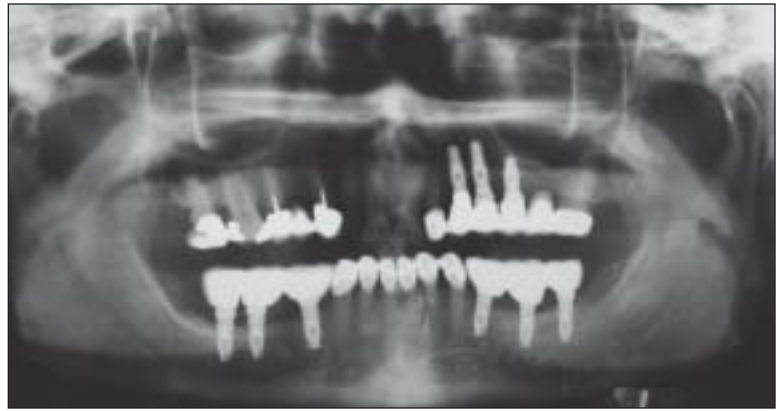
Fig 1 Panoramic radiograph demonstrating the position of the inserted implants in the mandibular right quadrant.

A 62-year-old woman underwent dental implant placement in the mandibular right quadrant by her dental practitioner in a private clinic. In the first stage, implants were inserted in the positions of the right first premolar, second premolar, and first molar (Fig 1). Six months later, second-stage surgery was carried out to expose the 3 implants. Following this procedure, the patient complained of a slowly growing swelling in the floor of the mouth on the right side. The patient consulted an oral surgeon, who advised her to remove the implants as an attempt to overcome the swelling. Eighteen months after their placement, all three implants were extracted (Fig 2). Three weeks following removal of the implants, the patient was referred to the authors' clinic for consultation. A clinical examination revealed a soft swelling, with a bluish appearance in the floor of the mouth (Fig 3). Milking saliva from the submandibular glands on both sides revealed adequate secretion without interference. There were no relevant radiologic findings in panoramic, occlusal, or occlusal oblique views. The swelling was diagnosed as an intraoral ranula. The patient underwent a successful marsupialization of the ranula under local anesthetics 1 month later. The diagnosis was confirmed by a histologic examination of the tissue removed from the ranula.

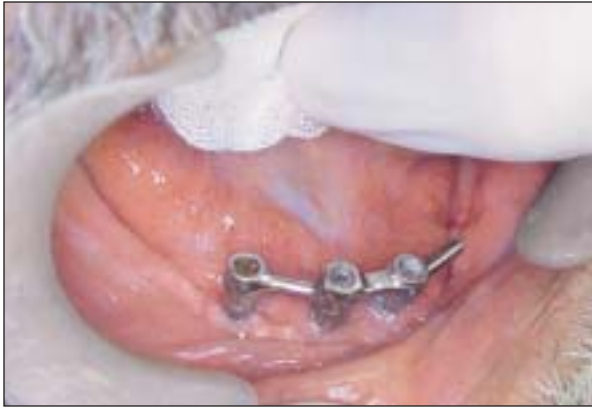
Fig 4 Clinical view of the implant in the anterior region of the mandible.

A 60-year-old man was referred to the authors' clinic due to an obstruction of his right Wharton duct following anterior mandibular dental implant insertion. The patient had undergone insertion of 3 dental implants in the anterior mandible by a private dental practitioner (Fig 4). Four months later, following the second-stage procedure, the patient began to suffer from recurrent swelling of his right submandibular gland during meals ("meal time syndrome"). The patient was referred to the authors' clinic, where a clinical examination revealed a total obstruction of his right Wharton duct orifice, with swelling of his right submandibular gland. No saliva came forth from the right submandibular orifice when the gland was milked. Local anesthesia was induced for endoscopic exploration of the right submandibular duct. The examination revealed a total obstruction of the anterior part of the Wharton duct and obstruction of the right sublingual duct (Bartholin duct). The obstruction was exposed and the duct was dilated. Sialo-stents were inserted into the Wharton duct to keep it open (Fig 5). Endoscopy revealed no other obstruction in the ductal system and demonstrated a healthy appearance of the submandibular gland. The stent was removed 1 month following the procedure, and a healthy salivary secretion was revealed. At a 1-year follow-up examination, the patient was asymptomatic, and the salivary gland function was excellent.

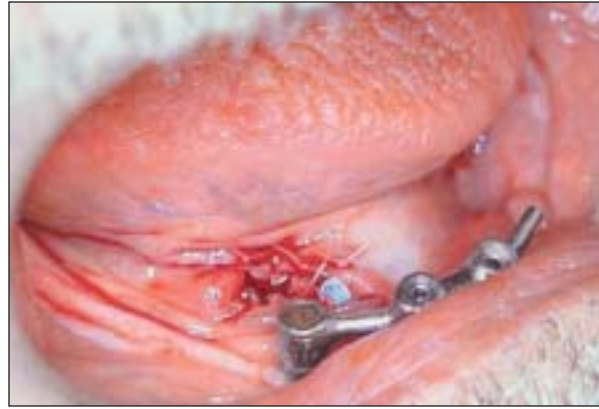
Fig 5 Stent inserted into the ductal system after sialoendoscopy of the right submandibular gland.

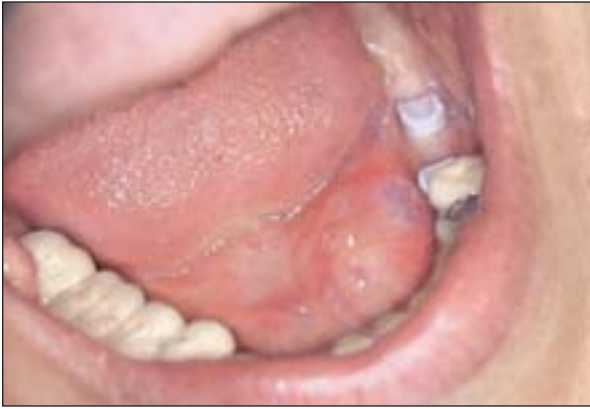
Fig 6 Clinical view of the swelling of the floor of the mouth.

A 50-year-old woman was referred to the authors' clinic because of constant swelling of the floor of the mouth (left side; Fig 6). Six months prior to her referral, the patient had received dental implants in the area of the mandibular right first and second molars. The swelling appeared following exposure of the implants and placement of cover screws 3 months after implant insertion. The swelling occurred in the floor of the mouth in close proximity to the implants. Clinical examination revealed soft tissue swelling extending from the implant located in the position of the right second molar to the anterior part of the mouth. Radiopaque dye (Ultravist iopromide; Schering, Berlin, Germany) was injected into the lesion (Fig 7), and the proximity of the swelling to the implant was noted in the radiograph. Ranula was diagnosed, and the patient underwent a successful marsupialization of the roof of the lesion under local anesthesia.

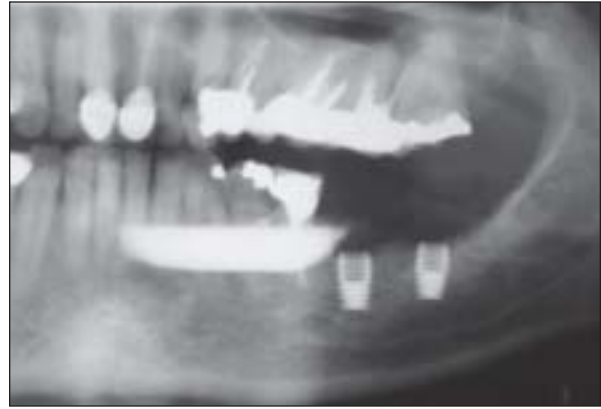
Fig 7 Radiograph showing the location of the ranula after injection of a radiopaque dye. Note its close proximity to the implants.
