Peri-implant Bone Loss Caused by Occlusal Overload: Repair of the Peri-implant Defect Following Correction of the Traumatic Occlusion. A Case Report

The purpose of this case report is to demonstrate the relation between occlusal overload and periimplant bone loss and the reversal of the situation after removal of the offending forces. The placement of an unstable removable prosthesis on 3 well-integrated implants that had been stable for 9 years caused noticeable bone loss after 6 months. The elimination of the traumatic occlusion reversed the situation, and a remarkable healing of the peri-implant tissue occurred until the pretrauma condition was nearly restored. The condition has been stable for the past 4 years. INT J ORAL MAXILLOFAC 2008;23:153–157

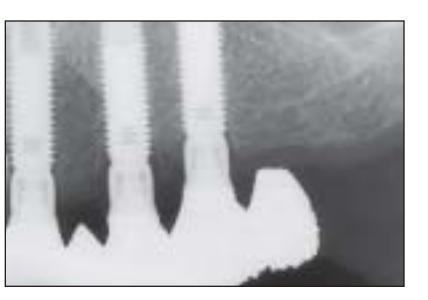
Fig 1 Peri-implant bone level 1 year postloading. Minimal bone loss on the intermediate implant. Stability of the bone level on the 2 adjacent implants, which were placed in the maxillary right first premolar and first molar sites.

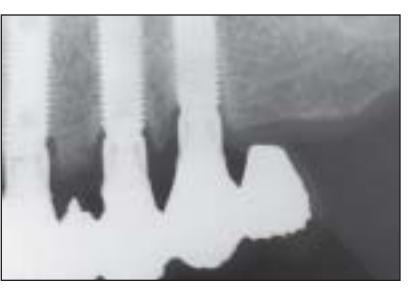
Fig 2 Bone level 5 years postloading. Stability of the peri-implant bone level can be observed.

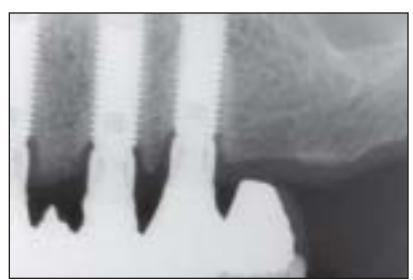
Fig 3 Bone level 9 years postloading. Bone positioned at the level of the first thread. Minimal bone loss occurred over 9 vears of functional loading

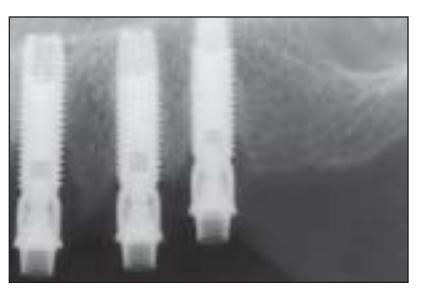
Fig 4 Six months after placement of the unstable removable overdenture. Note the severe bone loss on the implant in the maxillary right first premolar site (down to the sixth thread) and the maxillary right first molar site (down to the third thread). However, no bone loss was observed on the intermediate implant.

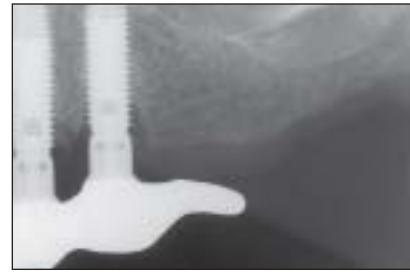
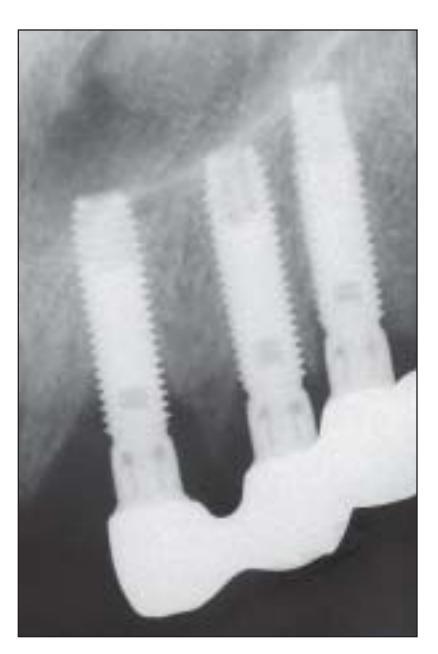
Figs 5 and 6 Six months after placement of the unstable removable overdenture. The implants were connected with a rigid bar, and the unstable overdenture was adjusted.

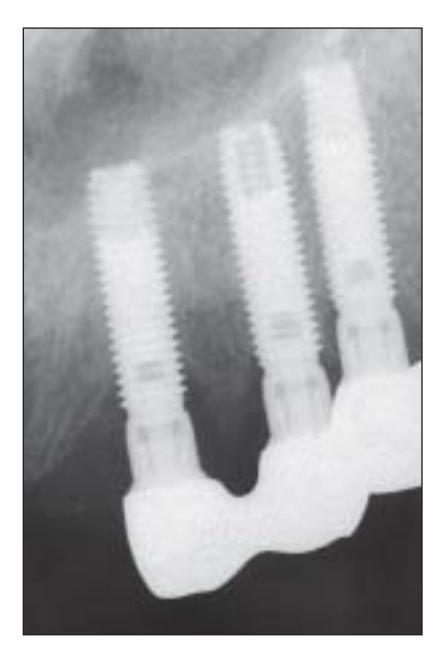
Fig 7 Six months after the elimination of the traumatic occlusion. Bone is at the level of the third thread of the implant placed in the maxillary right first premolar site. Bone level is near the pretraumatic level for the implant in the maxillary right first molar site.

fitted removable prosthesis was fabricated. Oral hygiene was reinforced to improve the patient's home care. The peri-implant condition was re-evaluated radiographically every 3 months. The bone lesions started to heal within 3 months after elimination of the traumatic condition. At 6 months, 1.5 mm of vertical bone gain could be observed on a periapical radiograph obtained with the same angulator but without standardization (Fig 7). At 1 year, the healing was remarkable (Fig 8). Eighteen months later, the bone defects were nearly completely healed. Two implants were then added in the anterior maxilla, and the patient was rehabilitated 4 months later with a full maxillary implant-supported fixed restoration. Periapical radiographs obtained 4 years later (Fig 9) confirmed the stability of the situation.

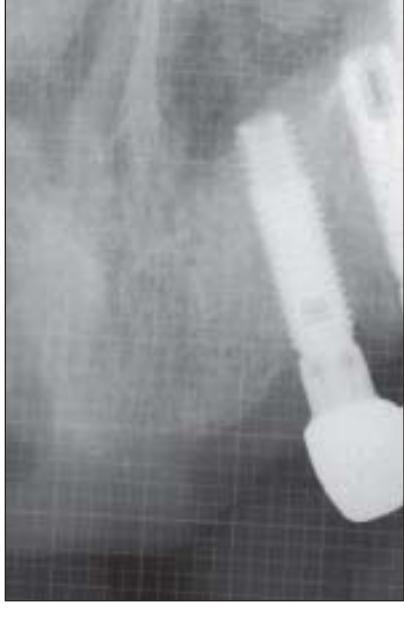
Fig 8 One year after elimination of the traumatic occlusion. Bone is near the level of the first thread on the 2 implants that experienced bone loss.

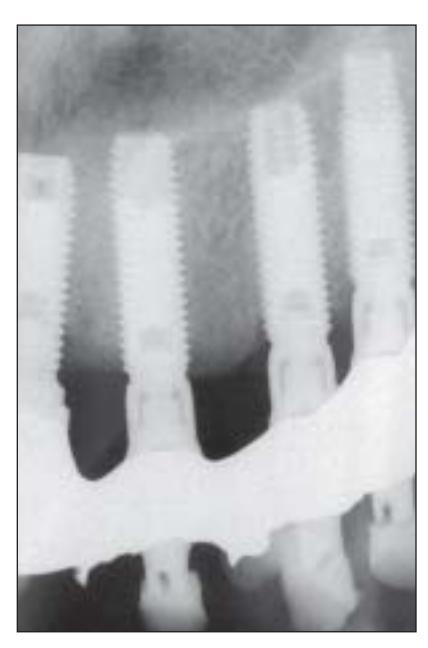
Fig 9 Four years after control of the traumatic occlusion and the placement of an implant-supported full maxillary fixed prosthesis. Note the stability of the bone level.
